REPORT NO. 1118

GUNFIRE TEST OF MODEL FJ-2 AIRPLANE
OXYGEN CYLINDER MOUNTING BRACKETS

FINAL Report

Gunfire Test of Model FJ-2 Airplane
Oxygen Cylinder Mounting Brackets

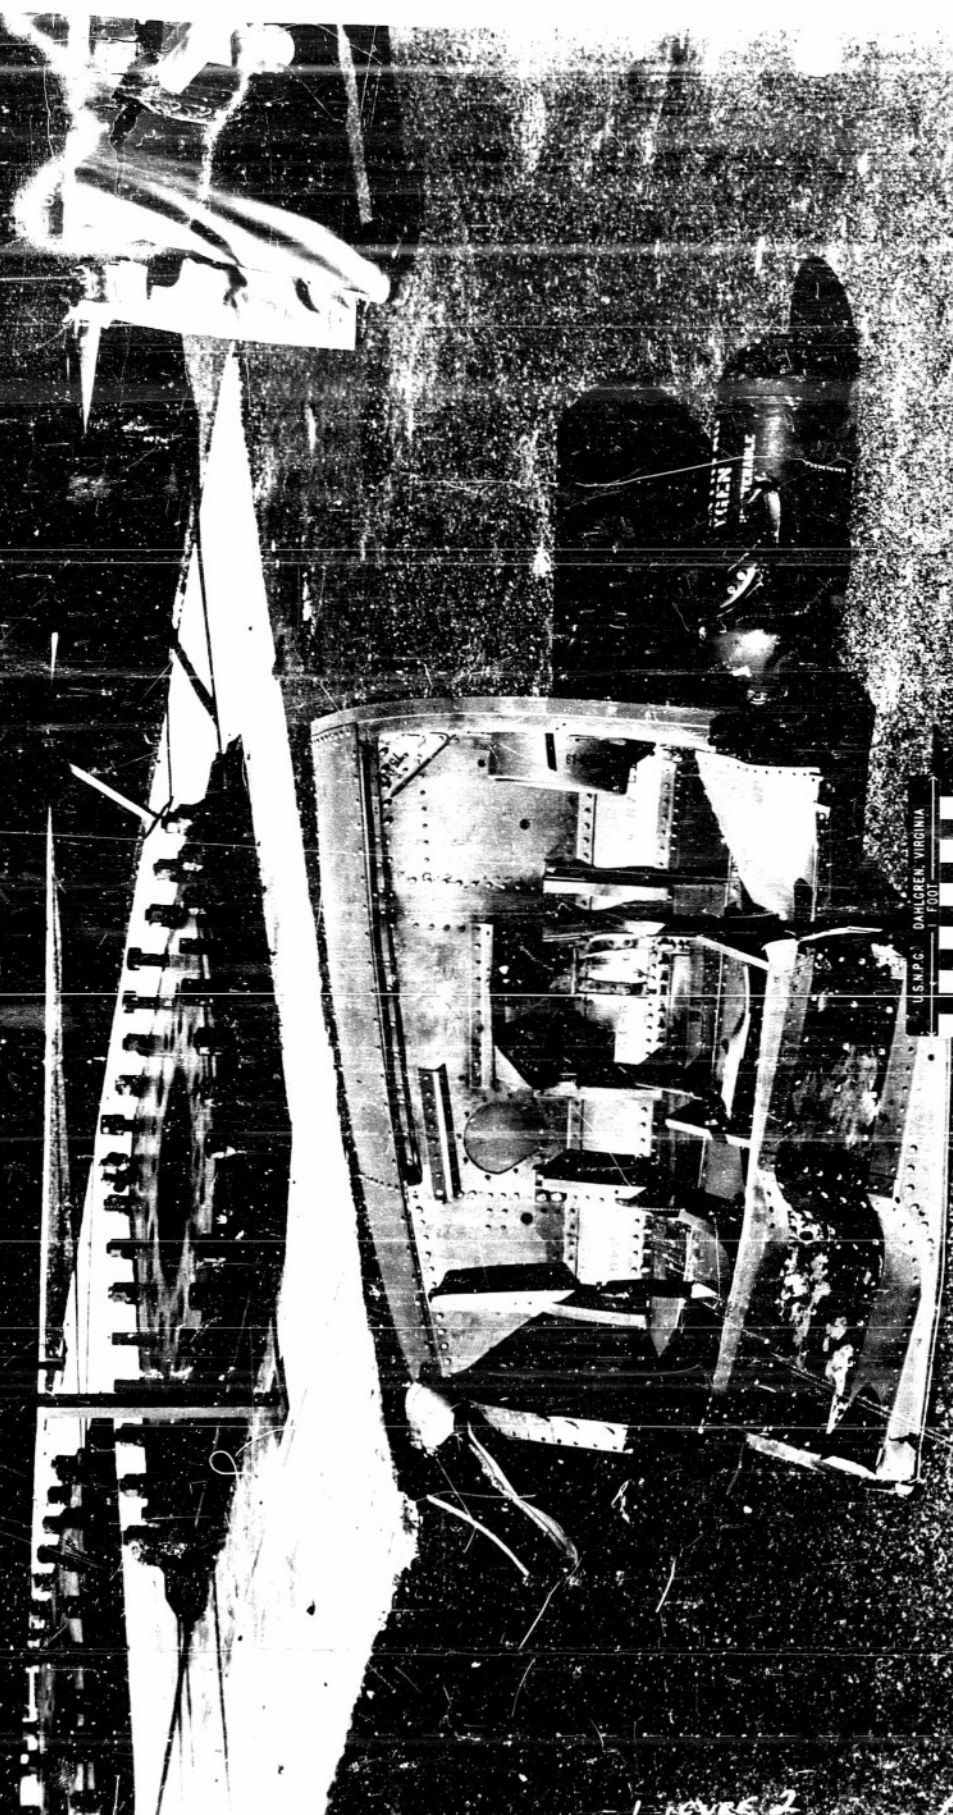
- a. The first bracket assembly tested failed to retain the oxygen cylinder, with damage being inflicted to the bracket and surrounding fuselage structure.

The first bracket assembly tested was mounted in a horizontal position with the longitudinal axis of the cylinder at an angle of 45° to the line of fire and attacked with a .50 caliber armor piercing projectile. The base of the cylinder was closer to the muzzle of the gun than was the neck. The initial impact occurred in the base of the cylinder, the projectile exiting through the aft wall. The effect of the projectile impact and/or the force initiated by the escaping oxygen resulted in the following damage: severed the angle attaching the Marman strap to the fuselage structure allowing the cylinder to fall free of the bracket; the access door was blown free and its hinges severed; the surrounding fuselage structure was torn and some sections were blown free. The damage to the test specimen is shown in Figure 2.

gunfire Test of Model FJ-2 Airplane Oxygen-cylinder Mounting Brackets. View showing damage inflicted to the first test specimen by a .50 caliber AP projectile impact and/or the force of the escaping oxygen. The test specimen was attacked at an angle of 45°. Figure 2

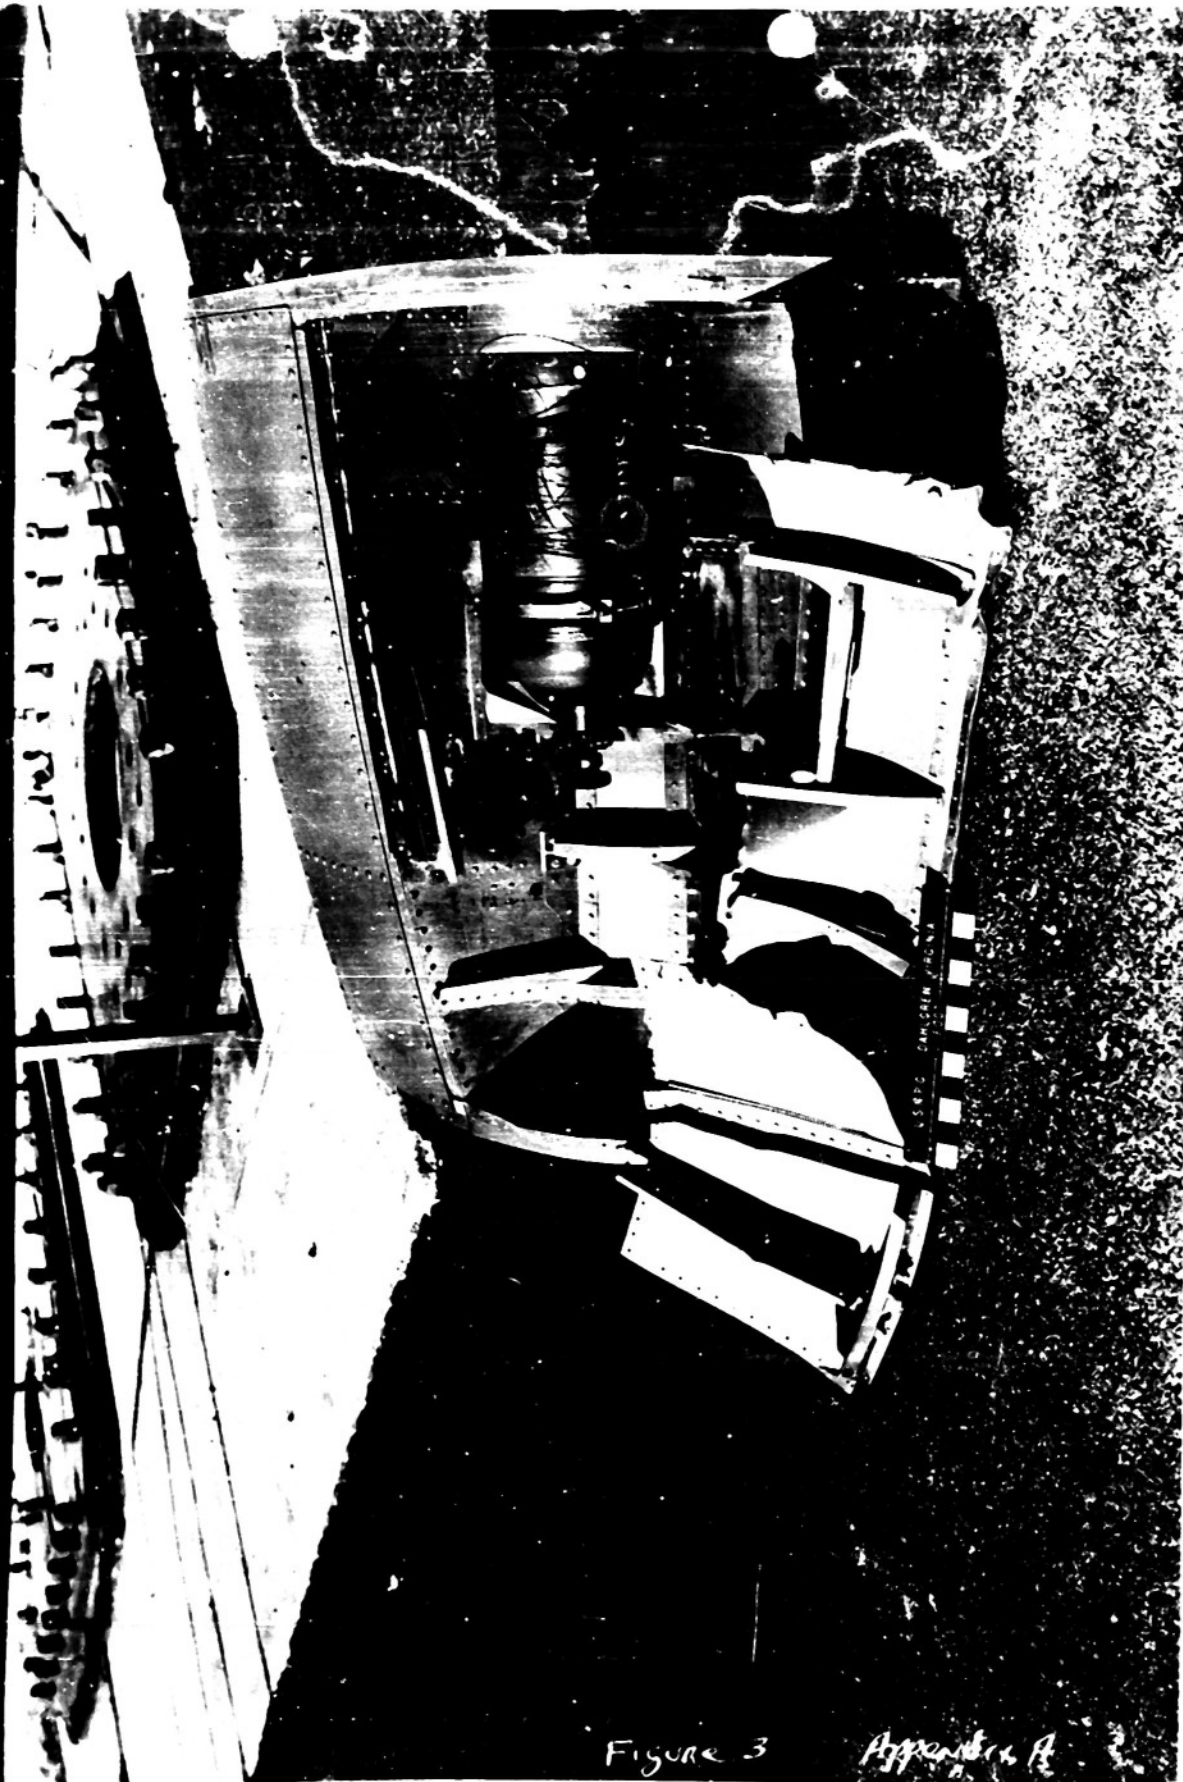
Figure 3

- b. The second bracket assembly tested retained the oxygen cylinder with no apparent damage to the bracket. The surrounding fuselage structure was torn and the access door was blown free.

The second bracket assembly tested was mounted in a horizontal position with the longitudinal axis of the cylinder at an angle of 35° to the line of fire and attacked with a .50 caliber armor piercing projectile. The base of the cylinder was closer to the gun muzzle than was the neck. The initial impact occurred in the forward end of the cylinder approximately 8" below the valve, the projectile exiting through the opposite wall immediately below the neck of the cylinder. The bracket retained the cylinder with no apparent damage, although as a result of the force of the escaping oxygen, the surrounding fuselage structure was torn and some sections were blown free. The damage to the test specimen is shown in Figure 3.

6 February 1953
Gunfire Test of Model FJ-2 Airplane Oxygen Cylinder Mounting Brackets. View showing damage inflicted to the second test specimen by a .50 caliber AP projectile impact and/or the force of the escaping oxygen. The test specimen was attacked at an angle of 35°.
